MASSTER TEST No 136
EXPANDABLE

SHELTER/CONTAINER REPORT

JUNE 1973

SUBJECT: Expandable Shelter/Container Report, MASSTER Test Number 136

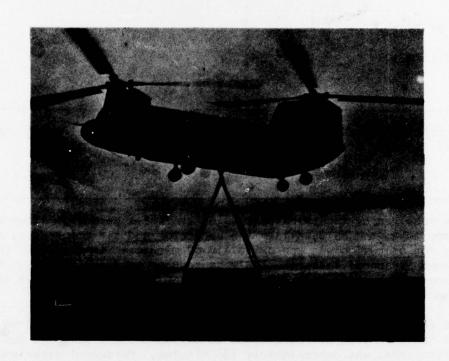
Figure 2-4. ES/C Being Hooked Onto CH-47 for Airlift

The ES/C was prepared for airlift by two qualified riggers in approximately 15 minutes (figure 2-4).

The ES/C with Dolly Set, M-829, was airlifted by a CH-47 helicopter to a speed of 75 knots. At 75 knots the ES/C began excessive oscillation. The ES/C was flown at 70 knots without difficulty. The ES/C tracked sideways when air transported (figure 2-5). When lowering the ES/C to the ground, the front of the ES/C was four inches lower than the back at initial ground contact. Analysis of the above results indicate that the ES/C in sheet metal shop configuration is easily transported by CH-47.

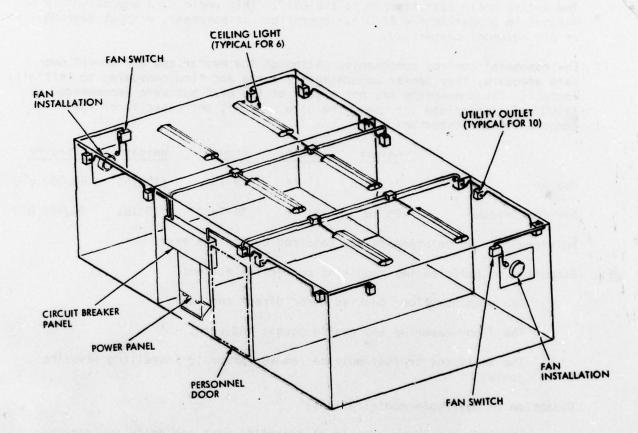
Figure 2-8. Lighting, Power, and Ventilation for ES/C

Lights. The six fluorescent ceiling lights and the one exterior 150 watt floodlight provided excellent illumination (figure 2-8).

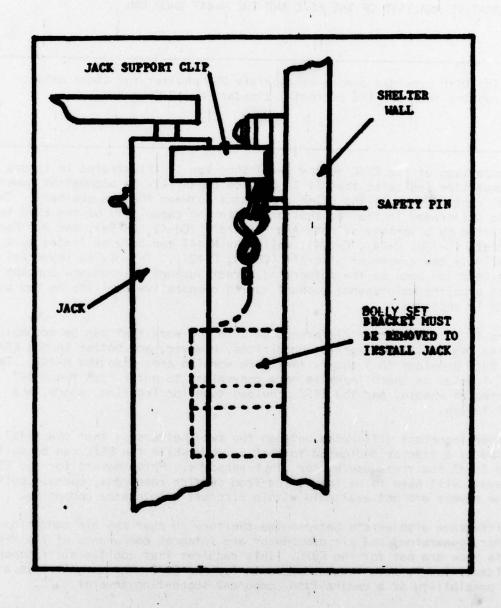
Figure 2-9. Dolly Set Bracket

Dolly set. The ES/C would better support the IDSM concept if the amount of time to prepare it for operations and movement could be reduced. Ten minutes of preparation time could be saved if the dolly set brackets could be left installed at all times. As currently designed the brackets must be removed to attach the leveling jacks which raise and level the ES/C. Further, it would be desirable if the ES/C could be leveled, expanded, and utilized with the entire dolly set attached to the ES/C. This would save approximately 40 minutes in preparing the ES/C for operations or movement, without degradation of air movement capability.

- . The aluminum floor buckled under direct sunlight.
- . The floor covering was easily gouged and worn.
- . The dolly set bracket must be removed prior to installing leveling jacks.

- . The ES/C should be capable of operation with the dolly set attached.
- . The environmental control components should be smaller and of less weight.

- . That deficiencies noted on page 2-11 be corrected.
- . That further testing of the ES/C in various aircraft maintenance shop configurations be conducted.
- . That appropriate modifications to the ES/C or Dolly Set be investigated that will allow the ES/C to be fully operational with the dolly set attached.
